RTA Weipa Pty Ltd

# Amrun Project Marine Pest Settlement Plate Monitoring Program

August 2017

Document number: CAL.01-4400-HH-REP-00002

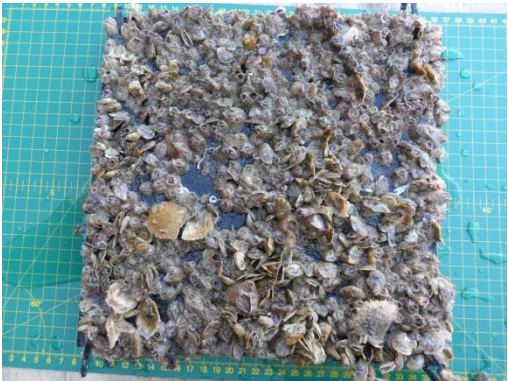
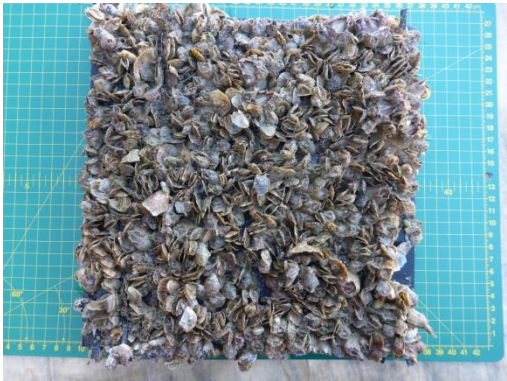
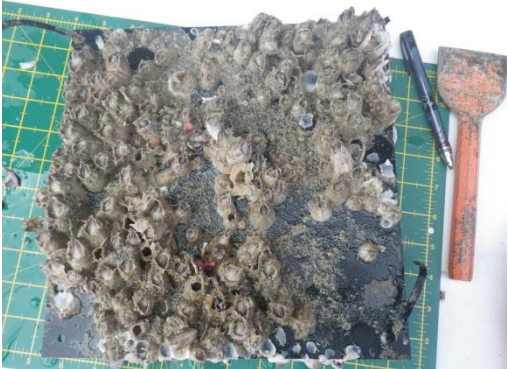
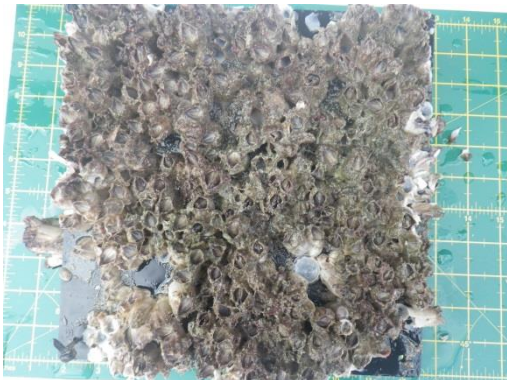
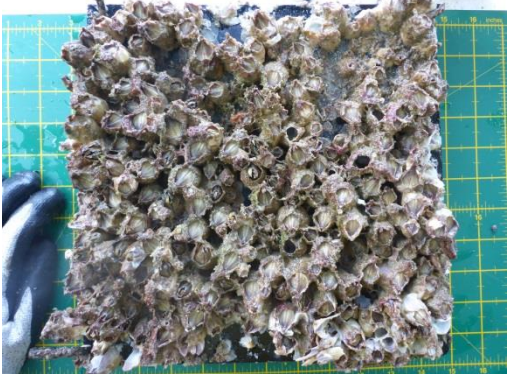
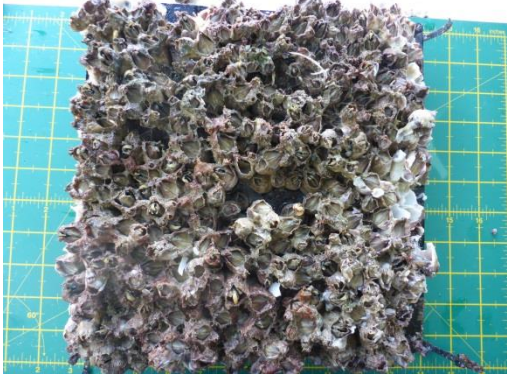
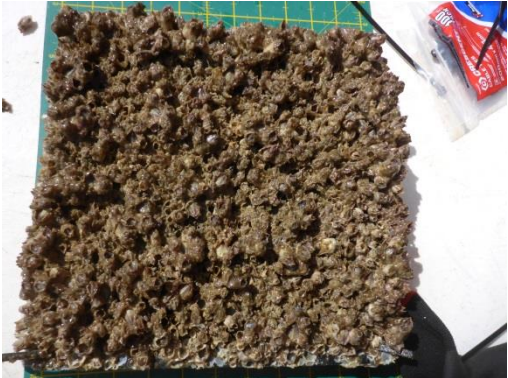
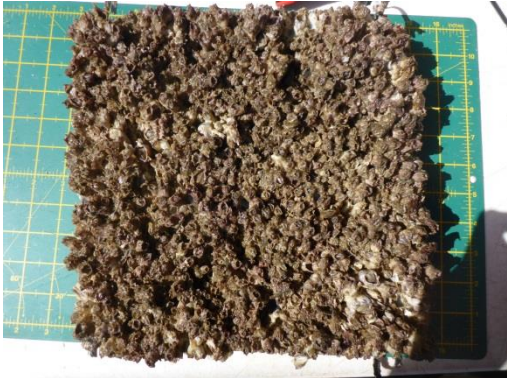
Representative photographs of biofouling communities for each sampling event – Boyd Bay, 3m

No marine pests were recorded on any sampling event during the reporting period. Biofouling on all surfaces was high with tertiary assemblages recorded for all sampling events, indicating plates were effective and the system would be successful in attracting marine pests, should they occur in the area. Representative images from each sampling event are presented below.
