RTA Weipa Pty Ltd

Amrun Project Marine Pest Monitoring Report

August 2018

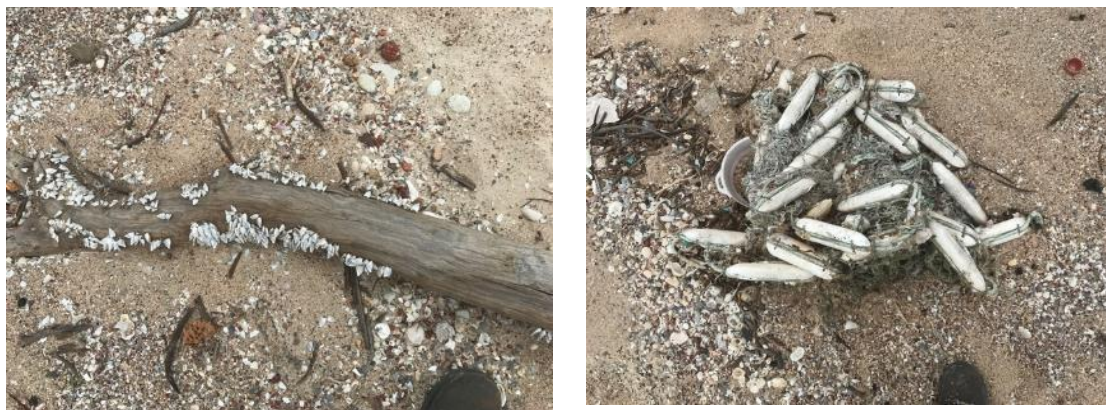
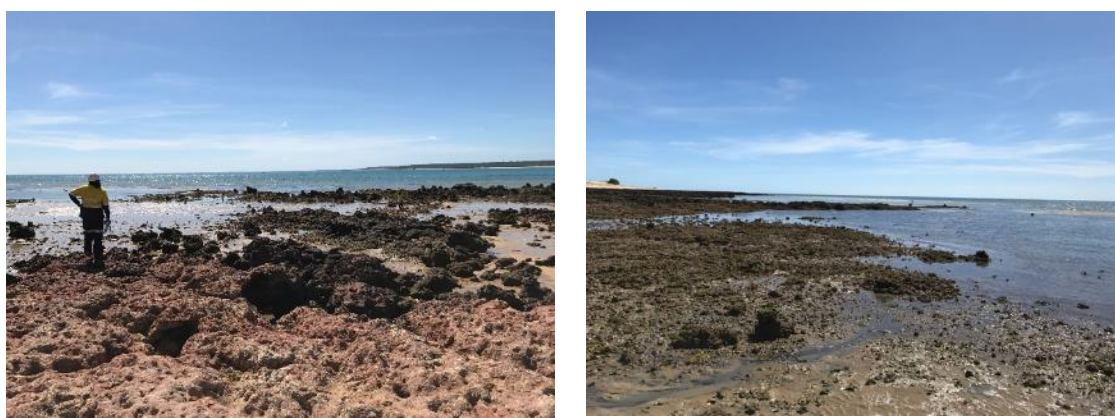
Figure 3 Images collected from wrack survey (top is accumulation of shells and rubbish), bottom is headlands investigated. No AGM were detected

Beach accumulation

Images of intertidal areas investigated

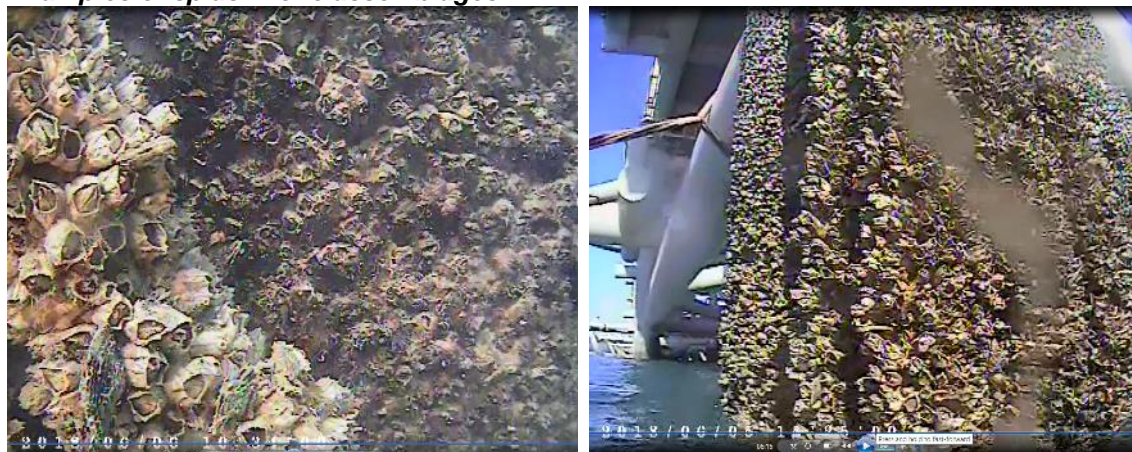
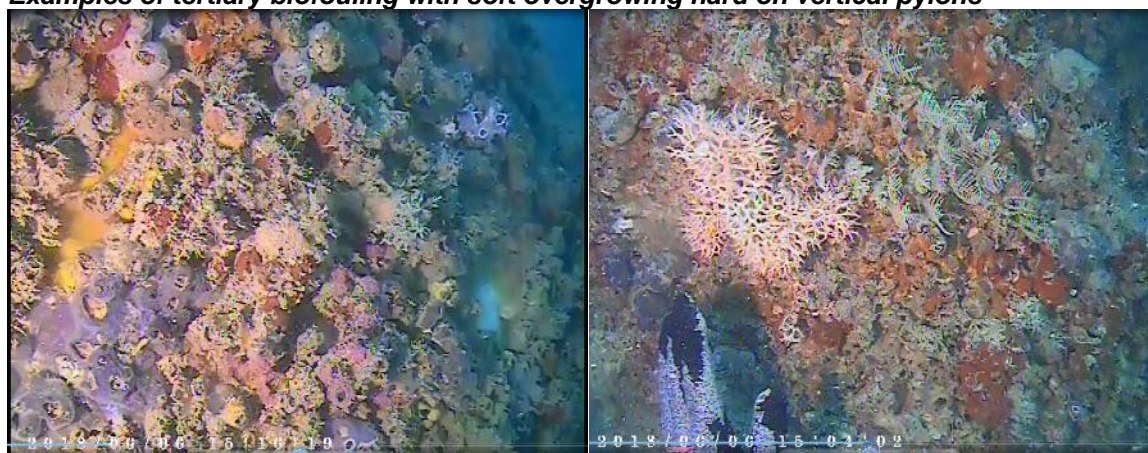
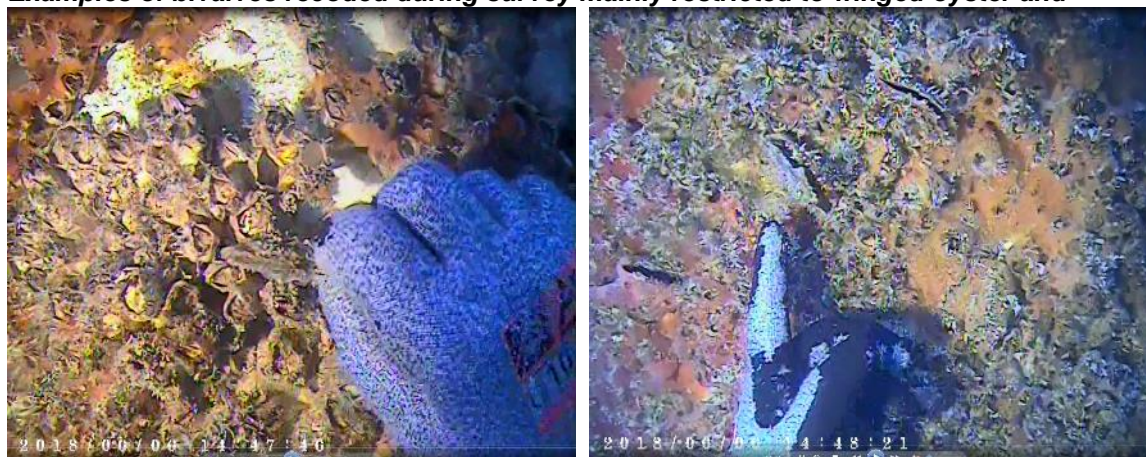
Figure 4 Images collected from diver survey

Pylon inspections occurred 29 May to 06 June 2018. No AGM were sighted or recorded during diver or video analysis. Images from the surveys are provided in **Figure 4** and **Figure 5**.

- Tertiary biofouling was observed on all vertical pylons with coverage at approximately 90% consistent on 10% soft biofouling and 90% hard. Hard cover predominately consisted of barnacles with a few oysters (fake pearl and winged), oysters were mainly sighted in the top 5 metres. Soft cover consisted of ascidians, sponges and algae which often cover the hard cover.
- Horizontal frames generally had lower levels of biofouling (secondary) at approximately 40% mainly consisting of barnacles with a thin sediment layer on top.
- A clear intertidal zone was identified at the top of the pylon, this was restricted to hard cover predominately consisting of barnacles and oysters.
- No areas of dense bivalve assemblages were recorded.

Examples of splash zone assemblages

Examples of tertiary biofouling with soft overgrowing hard on vertical pylons

Examples of bivalves recoded during survey mainly restricted to winged oyster and

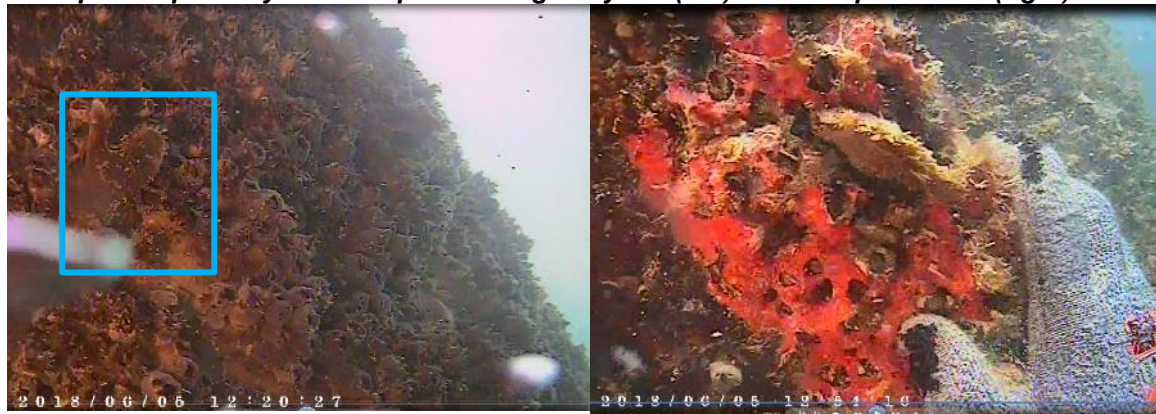
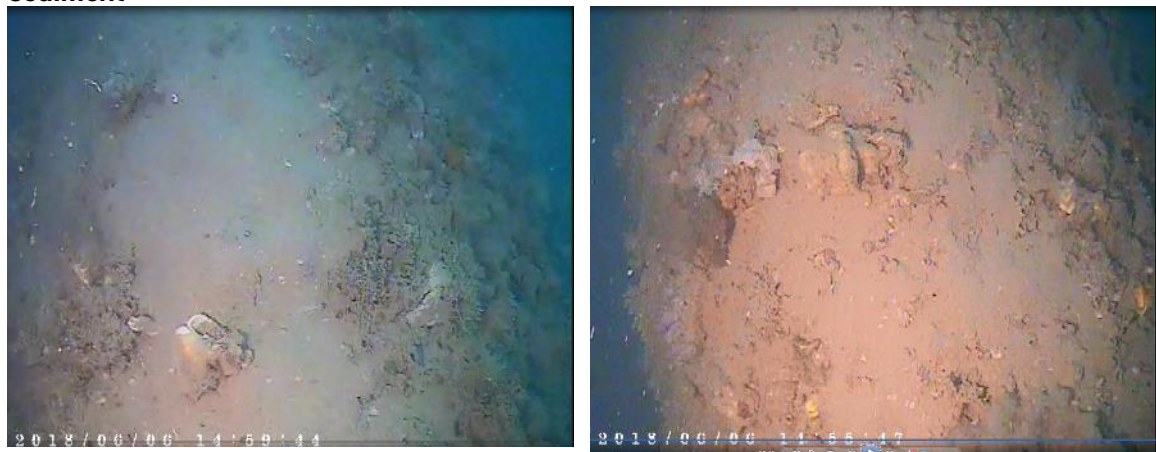
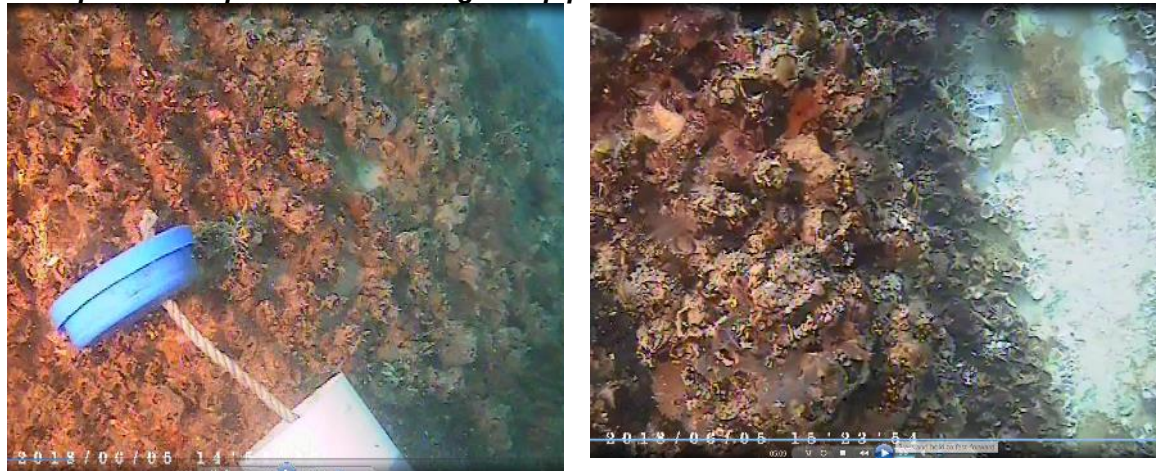
Figure 5 Images collected from diver survey (continued)

Examples of primarily bivalve species winged oyster (left) and fake pearl shell (right)

Examples of secondary biofouling on horizontal pylons with thin layer of overlapping sediment

Examples of sample collection using PVC pipe
