RTA Weipa Pty Ltd

# Amrun Project Marine Pest Monitoring Report

August 2019

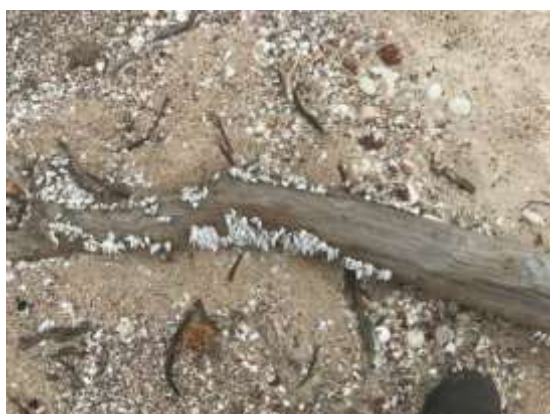
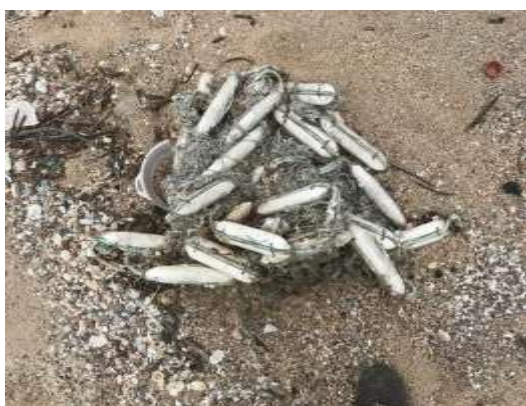
#### ***Beach accumulation***

**Figure 3** Images collected from wrack survey (top is accumulation of shells and rubbish), bottom is headlands investigated. No AGM were detected

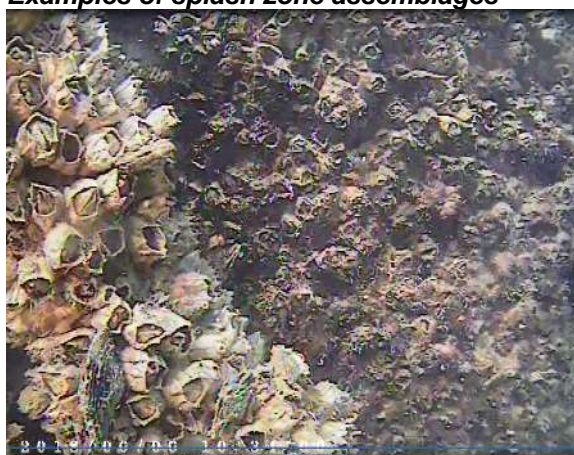
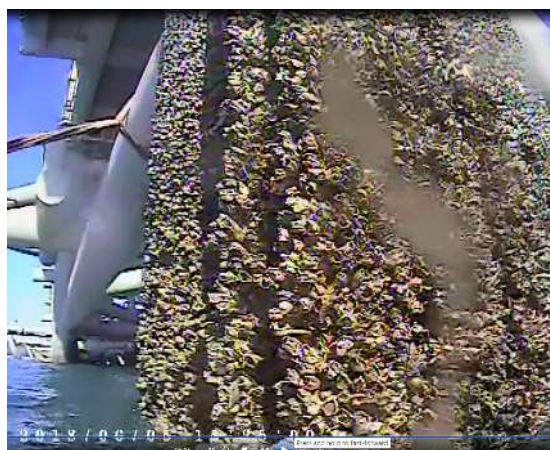
***Examples of splash zone assemblages***

**Figure 4** Images collected from diver survey

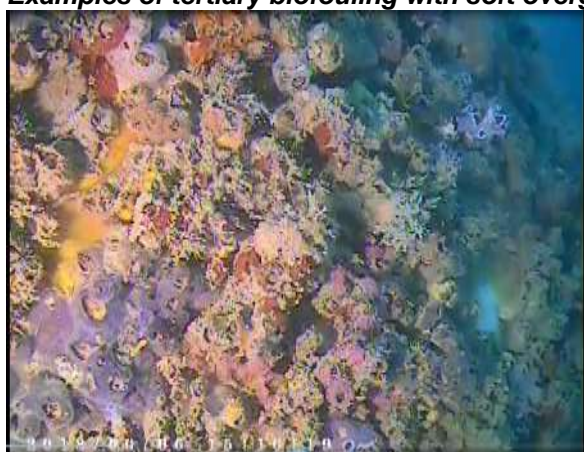
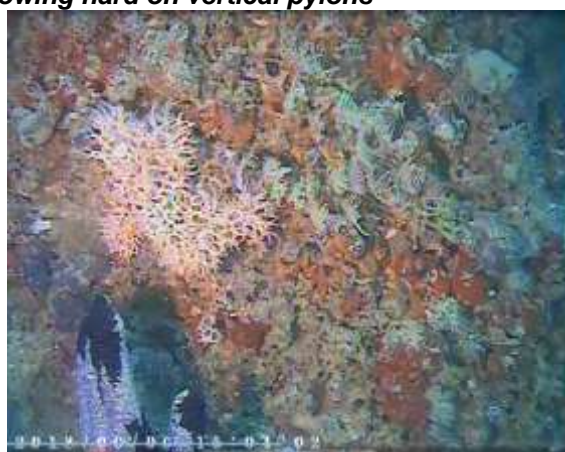
- Tertiary biofouling was observed on all vertical pylons with coverage at approximately 90% consistent on 10% soft biofouling and 90% hard. Hard cover predominately consisted of barnacles with a few oysters (fake pearl and winged), oysters were mainly sighted in the top 5 metres. Soft cover consisted of ascidians, sponges and algae which often cover the hard cover.
- Horizontal frames generally had lower levels of biofouling (secondary) at approximately 40% mainly consisting of barnacles with a thin sediment layer on top.
- A clear intertidal zone was identified at the top of the pylon, this was restricted to hard cover predominately consisting of barnacles and oysters.
- No areas of dense bivalve assemblages were recorded.

***Examples of tertiary biofouling with soft overgrowing hard on vertical pylons***

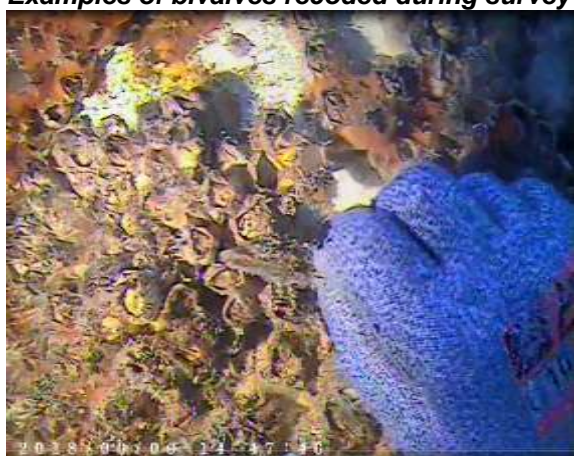
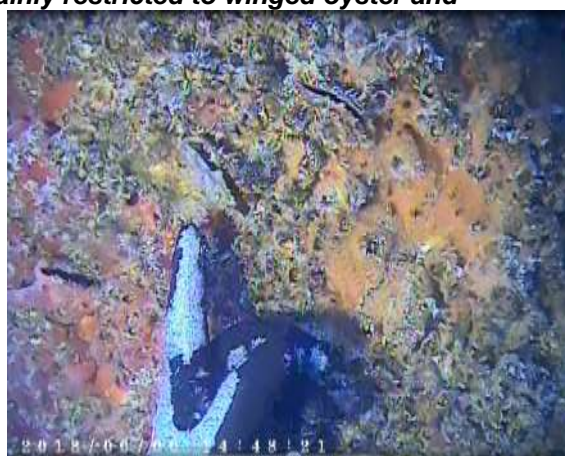
***Examples of bivalves recoded during survey mainly restricted to winged oyster and***

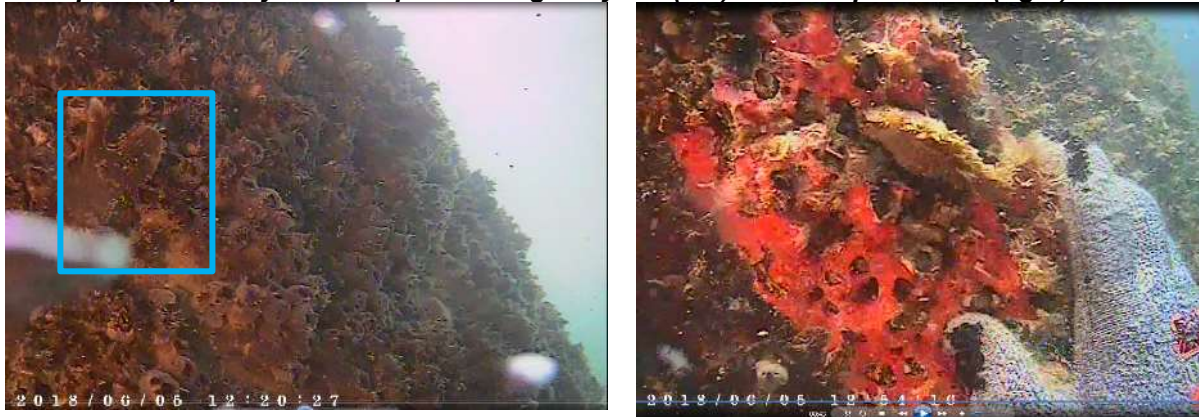
***Examples of primarily bivalve species winged oyster (left) and fake pearl shell (right)***

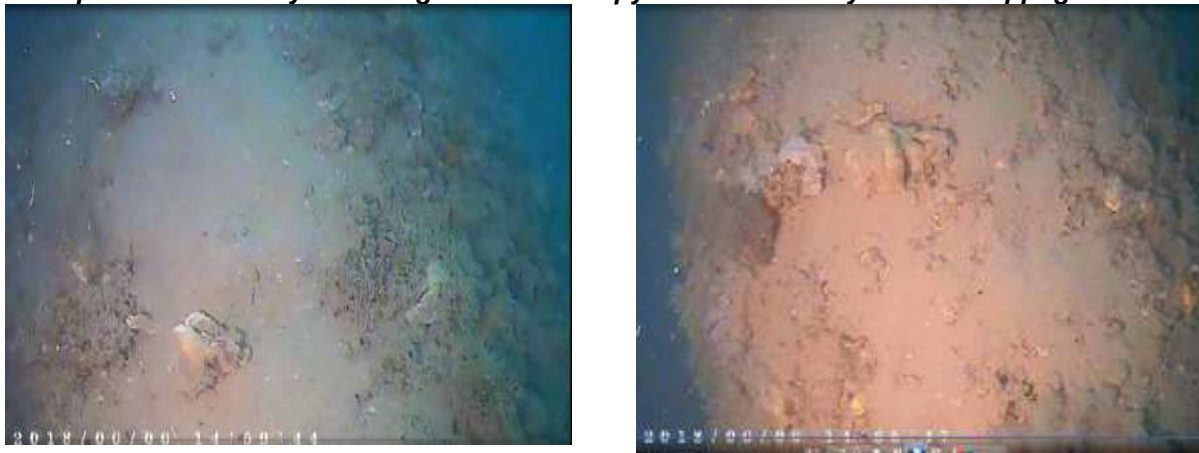
***Examples of secondary biofouling on horizontal pylons with thin layer of overlapping sediment***
