QMM Water Discharge Monitoring Data

March 2021

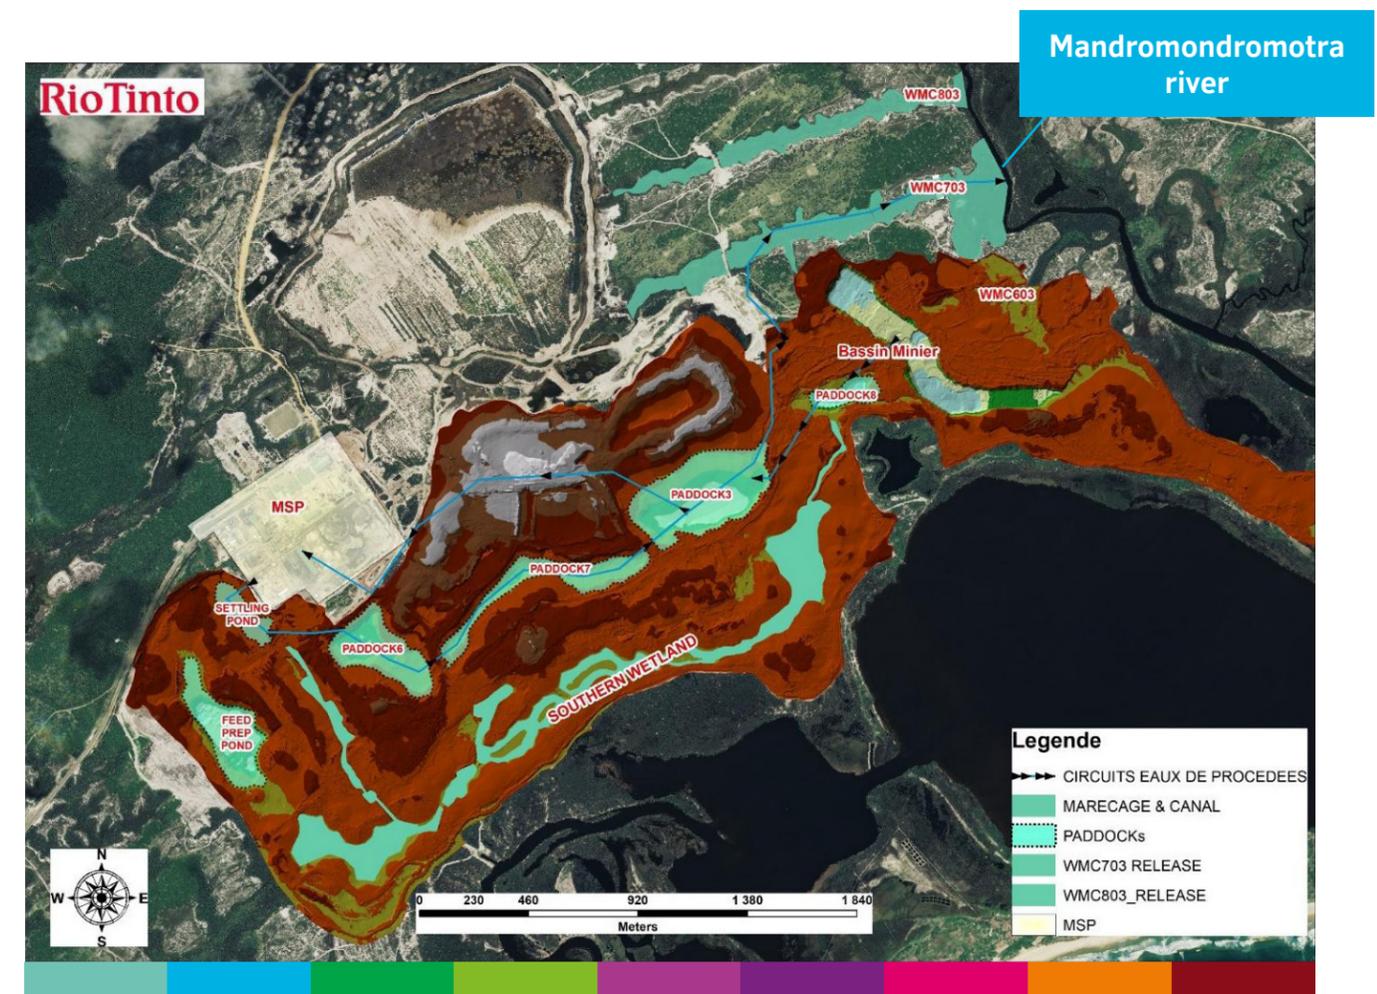
Figure 1: QMM current water flow

environment. According to our water management plan, only excess water inside mine operations is discharged to swamps a few hundred meters long before reaching the Mandromondromotra river. The discharge of water is not continuous and may not occur for periods that could extend to more than one month. Figure 1 shows a high-level representation of water flow through the mining area and connection with the surrounding environment.

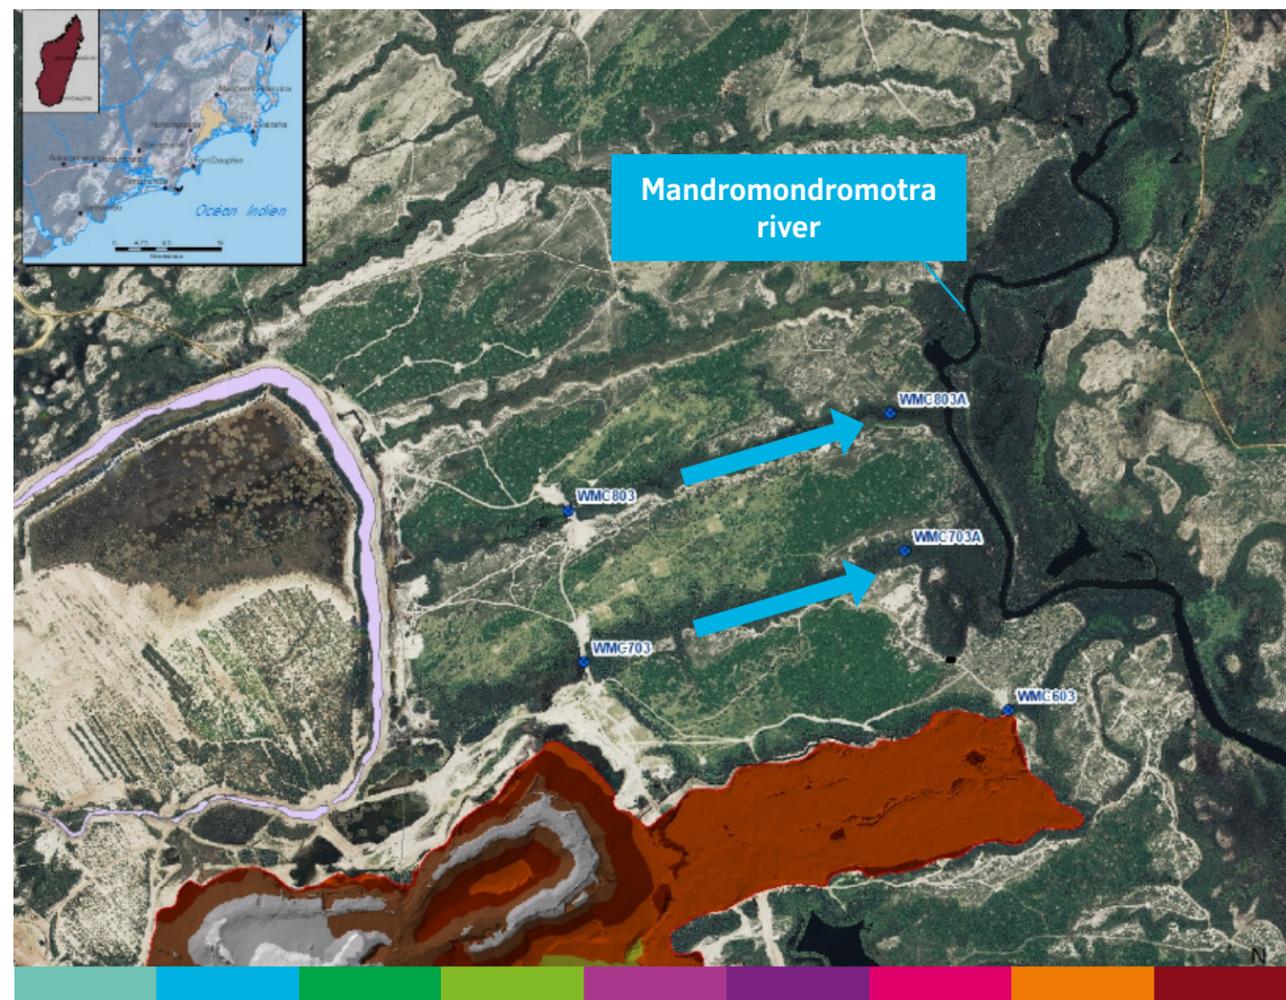
Figure 2: QMM permitted discharge points

These permits were renewed by the n°07-17/ANDEA permit on 31 August 2017 for five additional years (until 2022). Monitoring stations WMC 703 and WMC 803 were relocated downstream of their corresponding swamps and were respectively renamed WMC 703 (A) and WMC 803 (A) in August 2018, as shown in figure 2 below.

In addition to the water discharge data submitted to the regulator, QMM also monitors a range of additional water quality indicators, including total dissolved solids, pH, lead and zinc. For the purpose of this water discharge data summary, five (5) monitoring points are included for consideration and review (refer to figure 2 and figure 3 for relative locations):

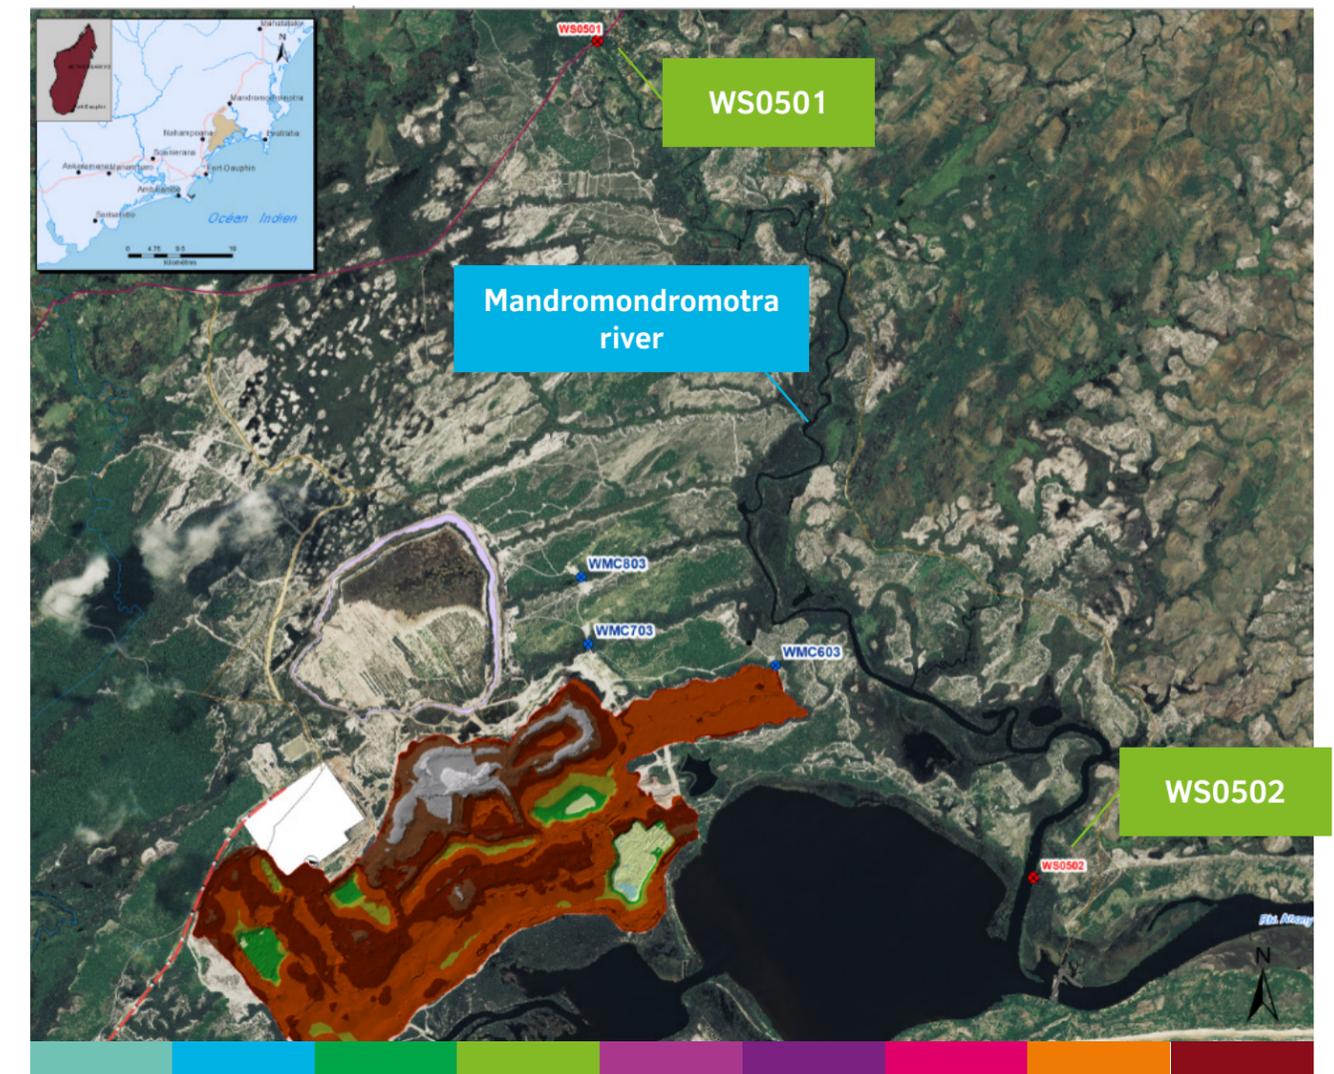
Figure 3: Monitoring station on Mandromondromotra river

QMM conducts ongoing water quality monitoring on various water bodies around the area of Mandena. Two of those monitoring stations are presented in this report: WS0501, upstream of the mining operations, and WS0502, downstream of the mining operations. Based on its approved monitoring protocol, QMM samples the surface water surrounding the mining site on a quarterly basis.

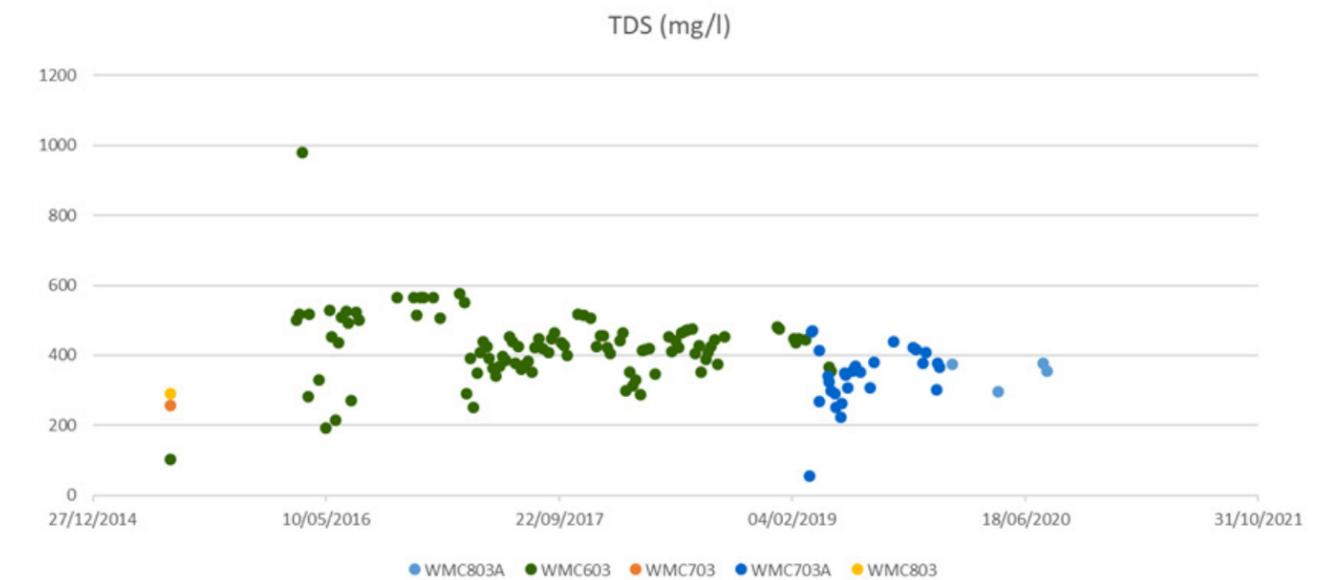
Figure 4: QMM Discharge Points – Total Dissolved Solids – During discharge events

Total Dissolved Solids (TDS) historical values (2015-2020) for the QMM discharge points are presented in Figure 4. As no discharge limit is prescribed for TDS in Malagasy regulation, the industry-accepted standard freshwater TDS limit of 1,000 mg/L could be utilized for relative comparison (ref: GRI Standard303 – Water and Effluents 2018). The figure shows that TDS level remained below this GRI standard 303.

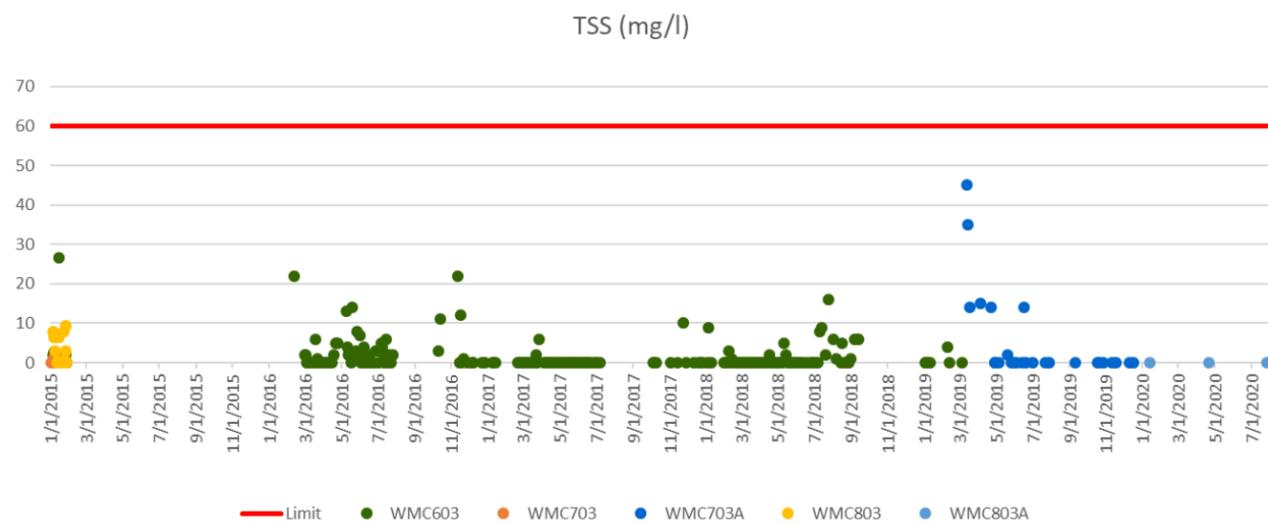
Figure 6: QMM Discharge Points – Total Suspended Solids - During discharge events

Total suspended solids (TSS) historical values (2015-2020) for the QMM discharge points are presented in Figure 6. The figure shows that QMM discharges have remained well below the permitted TSS discharge limit of 60 mg/L.

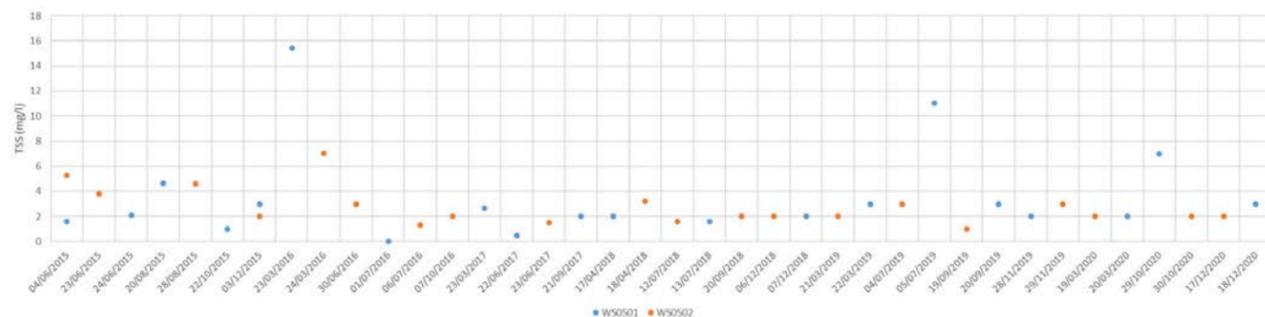
Figure 7: Water Monitoring locations located upstream and downstream of QMM discharge points on the Mandromondromotra River – Total Suspended Solids

Figure 7 – Water surface Total Suspended Solids (2015-2020) is shown for surrounding environment monitoring points.

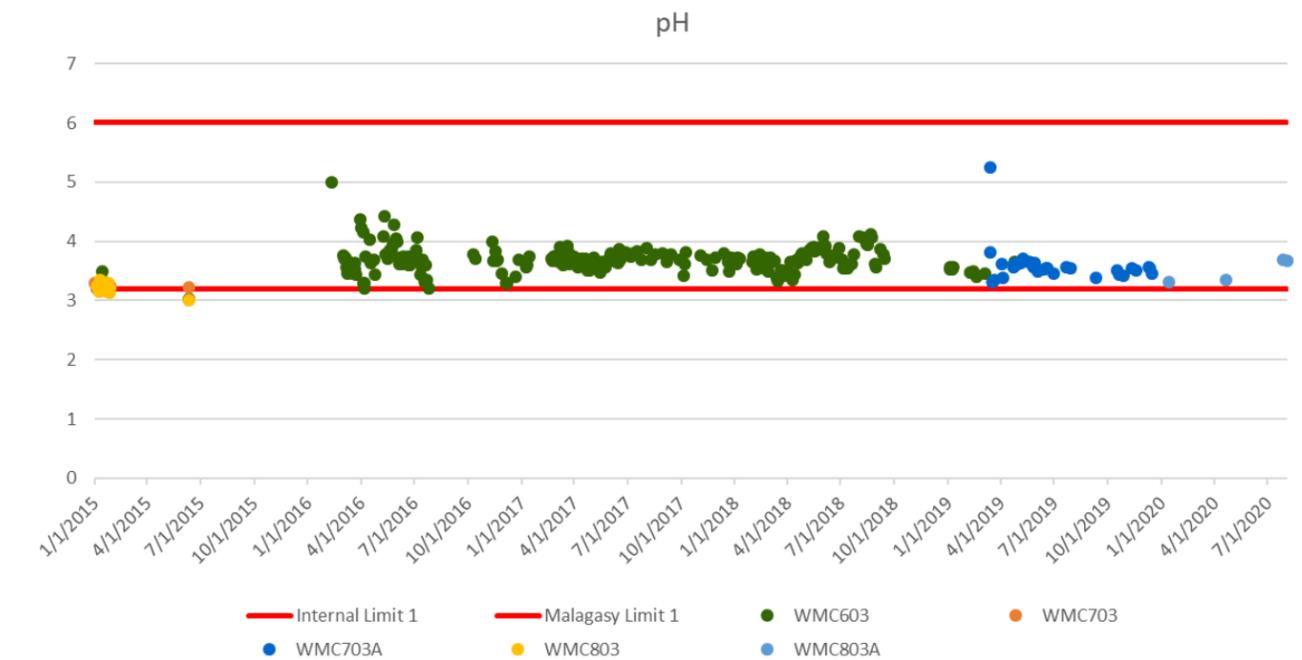
Figure 8: QMM Discharge Points – pH - During discharge events

pH historical values (2015-2020) for the QMM discharge points are presented in Figure 8. The figure shows that QMM discharges have remained within the permitted pH discharge range of 3.2 – 6³.

³ Because natural surface water around the mine is naturally acidic, instead of the pH range of 6-9 of the Decree, ANDEA authorised discharge to QMM at a pH range from 3.2 to 6. This was done in order to prevent potential ecological shock of releasing higher pH values into the naturally acidic natural surface water.

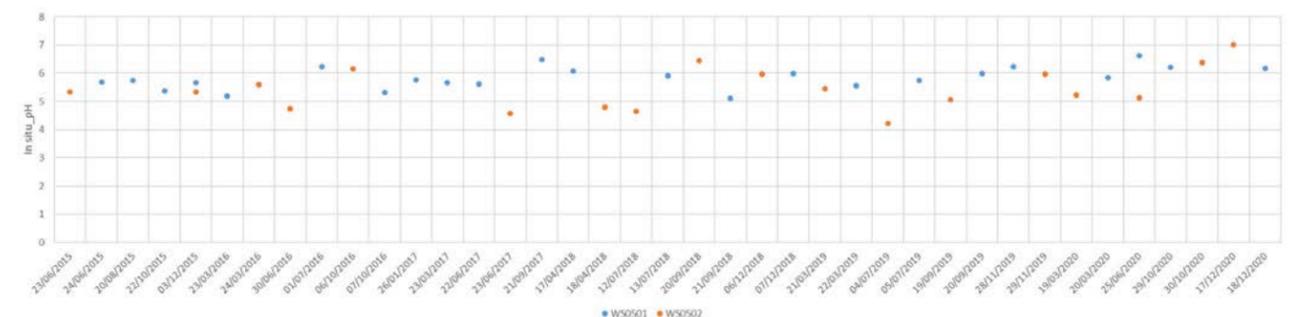
Figure 9: Water Monitoring locations located upstream and downstream of QMM discharge points on the Mandromondromotra River – pH

The water surrounding surface pH analysis shows a pH around 5 to 6.

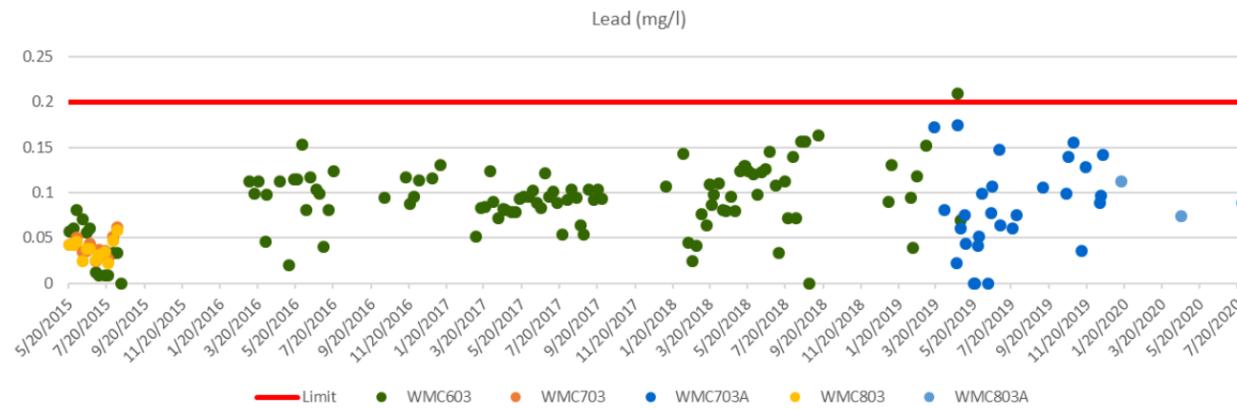
Figure 10: QMM Discharge Points – Lead (Pb) - During discharge events

Lead historical values (2015-2020) for the QMM discharge points are presented in Figure 10. The figure shows that except for one (1) sample on 25/4/2019 at WMC 603, QMM discharges have remained below the permitted lead discharge limit of 0.2 mg/L.

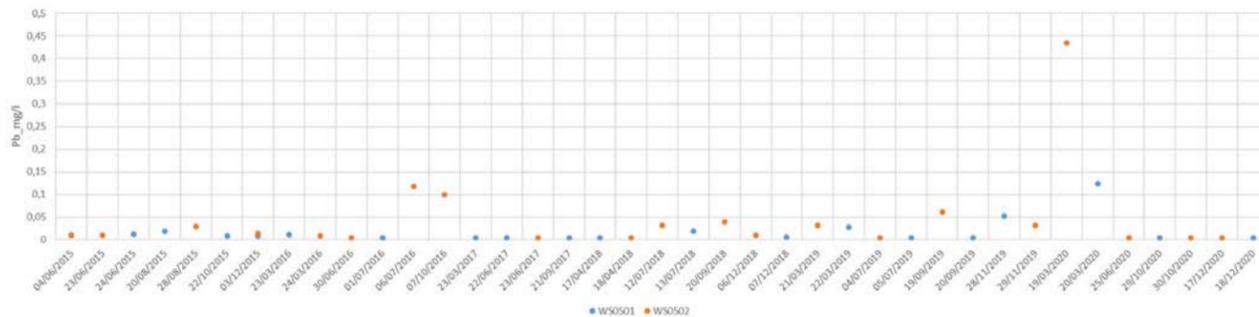
Figure 11: Water Monitoring locations located upstream and downstream of QMM discharge points on the Mandromdromotra River – Lead (Pb)

Figure 11 lead value over the same period for surrounding environment monitoring points.

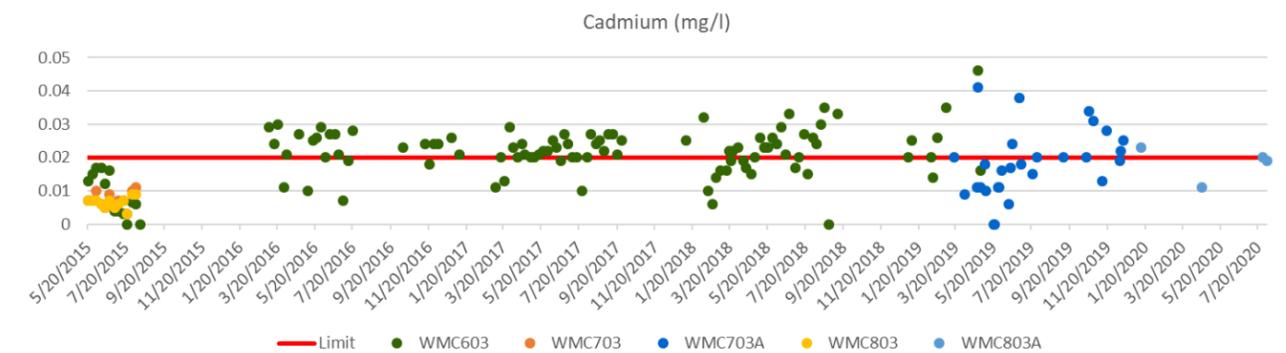
Figure 12: QMM Discharge Points – Cadmium (Cd) - During discharge events

Cadmium historical values (2015-2020) for the QMM discharge points are presented in Figure 12. The figure shows that exceedances of the permitted cadmium discharge limit of 0.02 mg/L have occurred over the historical period for WMC 603, WMC 703A and 803A.

WMC 603 has been the main discharge point since the permit approval. At the beginning of the use of discharge point WMC 603, the swamps were able to fully filter the discharged water. However, after a certain period of time, the swamps were less efficient, and exceedances occurred. Mitigating actions validated and agreed with ANDEA include:

- Reducing flow for WMC 603 by splitting discharge water volume between WMC 603 and WMC 703.
- Optimizing swamp efficiency by increasing the length of the swamps; WMC 703 and WMC 803 were relocated to WMC 703A and WMC 803A to allow a longer filtration time in the swamp area (see also section 3).
- New discharge point requested in March 2020 (WMC 903).

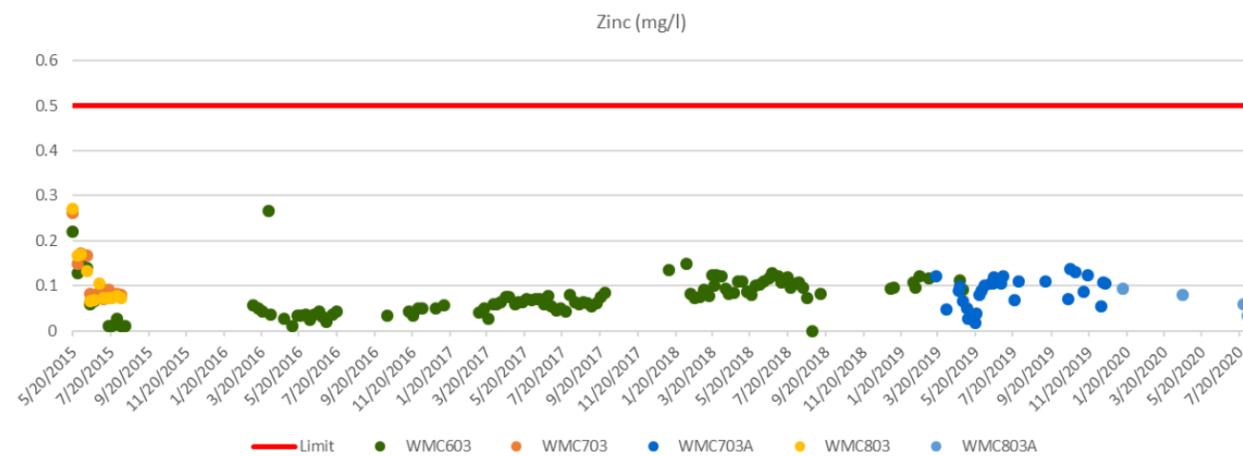
Figure 14: QMM Discharge Points – Zinc (Zn) - During discharge events

Zinc historical values (2015-2020) for the QMM discharge points are presented in Figure 14. The figure shows no exceedance compared to the Malagasy regulations, which is 0.5 mg/L.

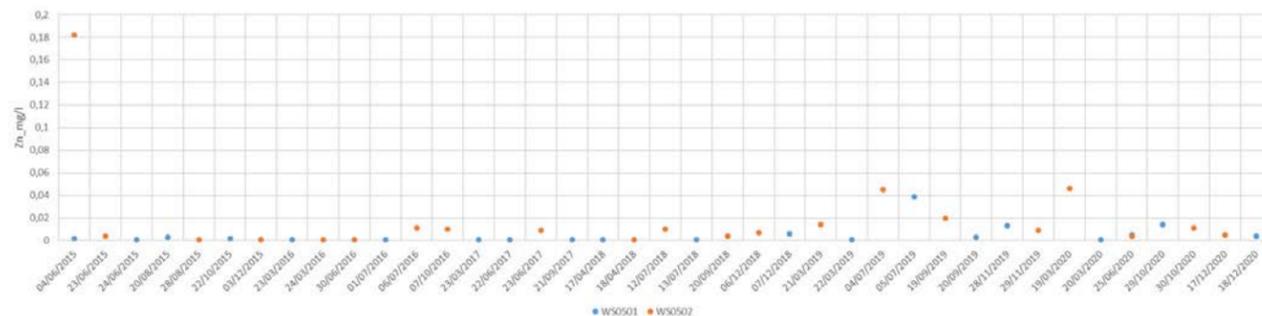
Figure 15: Water Monitoring locations located upstream and downstream of QMM discharge points on the Mandromdromotra River – Zinc (Zn)

Figure 15 shows zinc value over the same period for surrounding environment monitoring points.

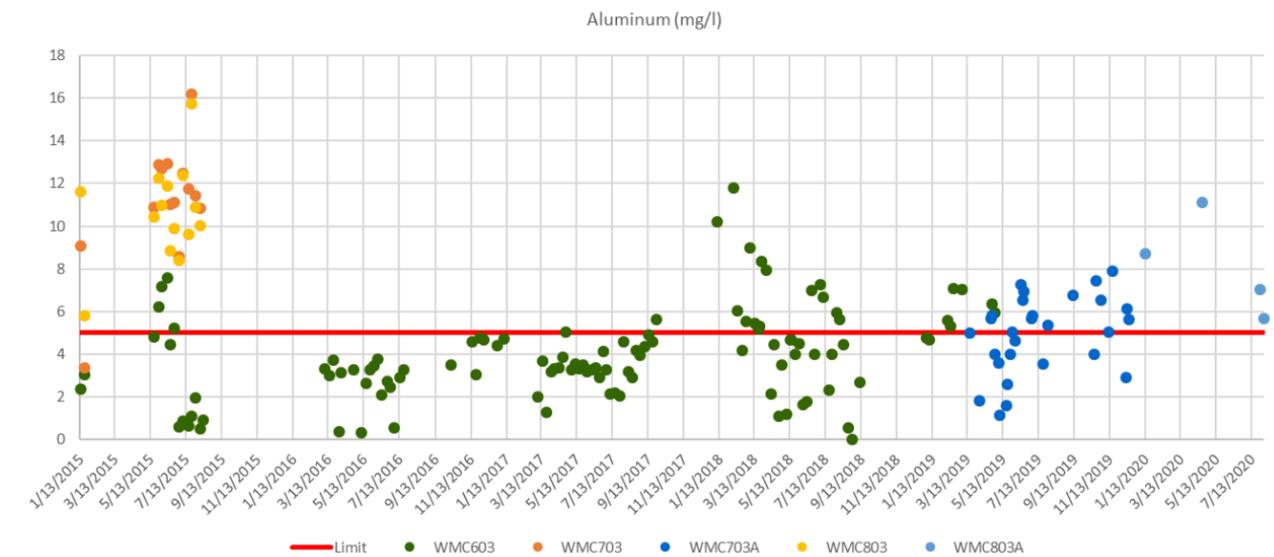
Figure 16: QMM Discharge Points – Aluminium (Al) - During discharge events

Aluminium historical values (2015-2020) for the QMM discharge points are presented in Figure 16. The figure shows exceedances of the permitted Aluminium discharge limit of 5 mg/L at the discharge points.

WMC 603 was the main discharge point since his permit approval. In the beginning, the swamps were able to fully play their filtering role. After a certain period of time, the swamps were less efficient, and there were some exceedances. Actions validated with ANDEA were:

- Reducing flow for WMC 603 by splitting water between WMC 603 and WMC 703.
- Optimizing swamp efficiency by increasing the length of the swamps; WMC 703 and WMC 803 were relocated to WMC 703A and WMC 803A to allow a longer filtration time in the swamp area (see also section 3).
- New discharge point request since March 2020 (WMC 903).

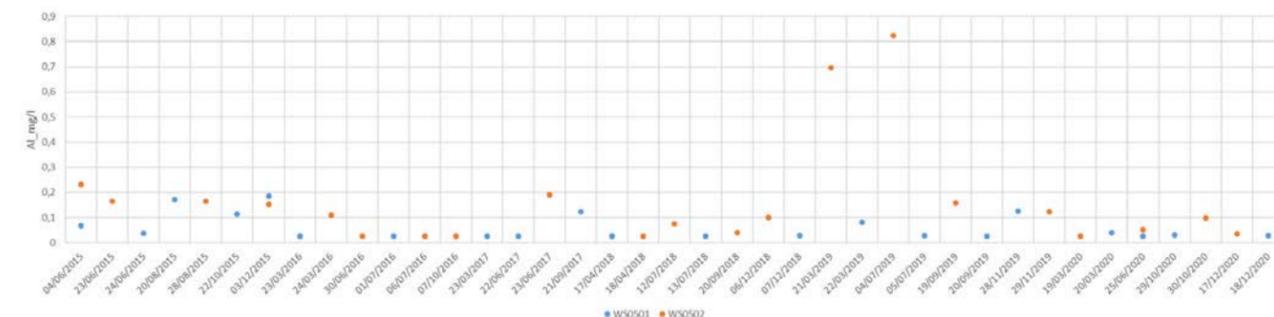
Figure 17: Water Monitoring locations located upstream and downstream of QMM discharge points on the Mandromdromotra River – Aluminium (Al)

Figure 17 shows aluminium value over the same period for surrounding environment monitoring points.

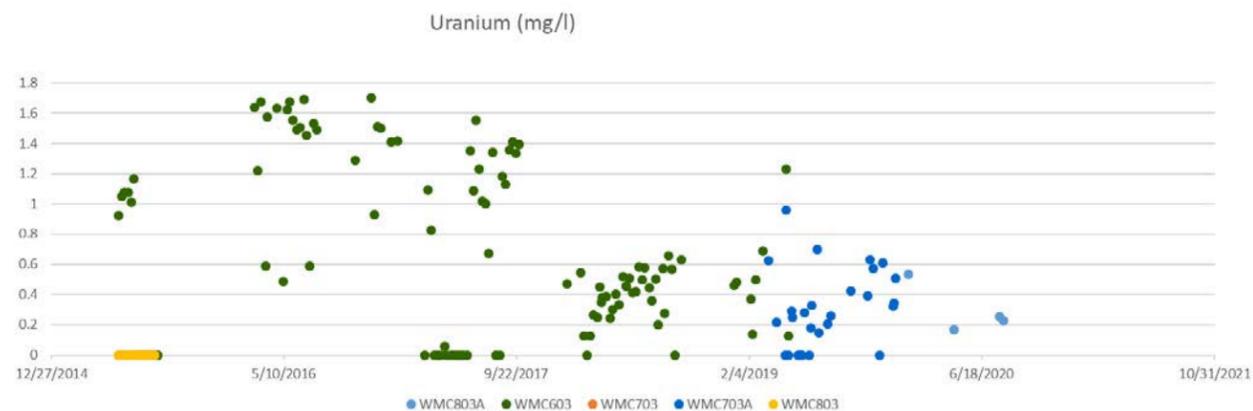
Figure 18: QMM Discharge Points – Uranium (U) - During discharge events

Uranium historical values (2015-2020) for the QMM discharge points are presented in Figure 18. No discharge limit is prescribed for uranium.

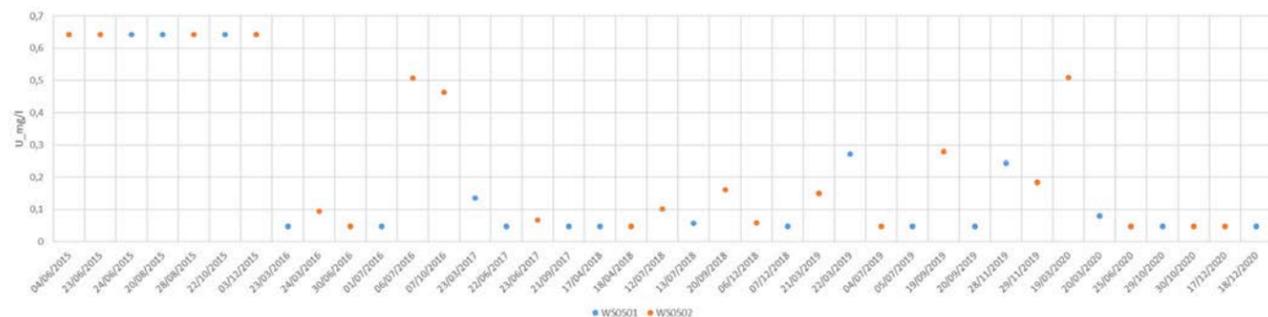
Figure 19: Water Monitoring locations located upstream and downstream of QMM discharge points on the Mandromdromotra River – Uranium (U)

Figure 19 shows uranium value over the same period for surrounding environment monitoring points.
