Rio Tinto Alcan Weipa

# Temporary Barge Plan

July 2015

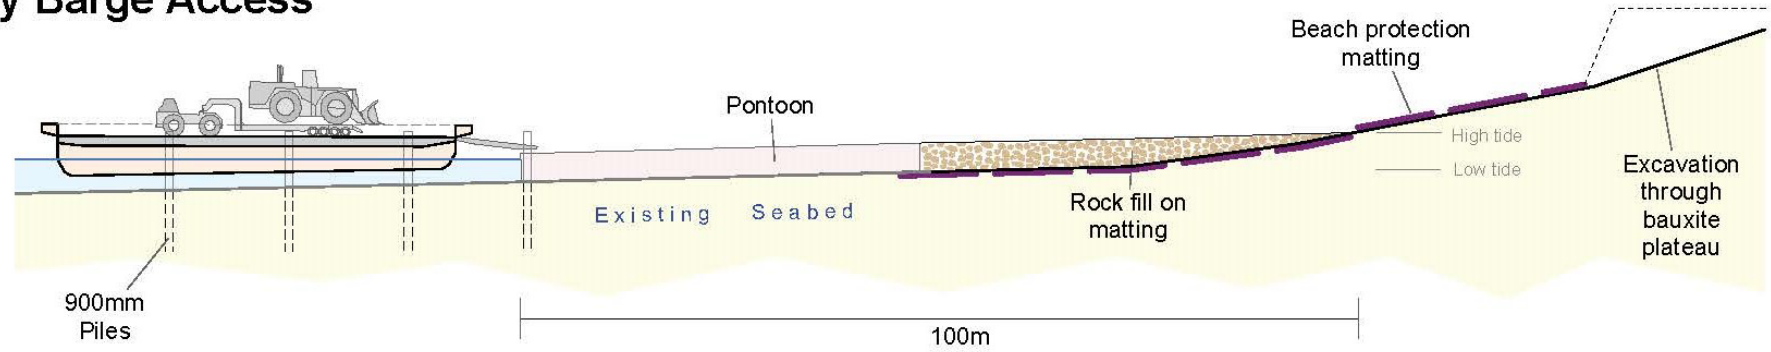
Figure 3 Temporary Barge Facility (Conceptual Plan)

The Temporary Barge Facility will consist of a pontoon (dumb barge) approximately 30m by 12m held in position with anchors (fore) and piles (aft). Piles will be installed using a vibratory hydraulic hammer from a barge. Semi-flexible pre-cast concrete matting (approximately 7.5m wide and 85m long laid) will be laid on the beach starting from the landward end and extend from the cutting in the bauxite plateau to the pontoon (Figure 3). The matting will be anchored in position by 1m steel pins. Approximately 2,000m<sup>3</sup> of geochemically-inert rock (+400mm) may need to be placed as loose fill on the concrete matting between high tide and pontoon to keep equipment out of salt water. The rock fill will be brought in from the land and progressively pushed out. No excavation of

the sea bed will be required to construct the facility. It will be designed by a qualified marine engineer and have sufficient draft to minimise scouring. Eight 900mm diameter piles will be installed by low-impact vibratory piling for safe mooring and operation of the barge. Should driven piles be required, a soft start procedure will be followed and observation and exclusion zones established in accordance with Condition 12 of the EPBC 2010/5642 approval. A cutting through the plateau about 3-4m high, 7.5m wide at the base plus batters, and approximately 50m long is required to establish suitable grades.

Semi-flexible pre-cast concrete matting (approximately 7.5m wide and 85m long) will be laid on the beach to reduce risk of beach erosion or scouring from vehicle traffic. Ten days prior to the

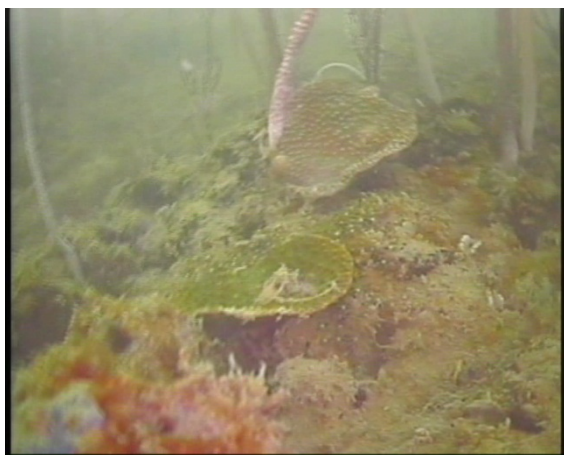
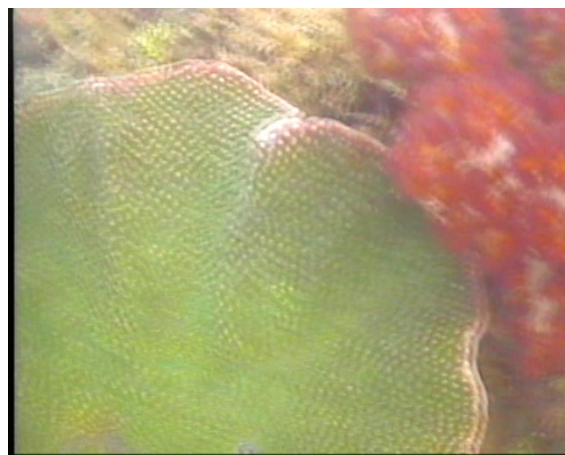
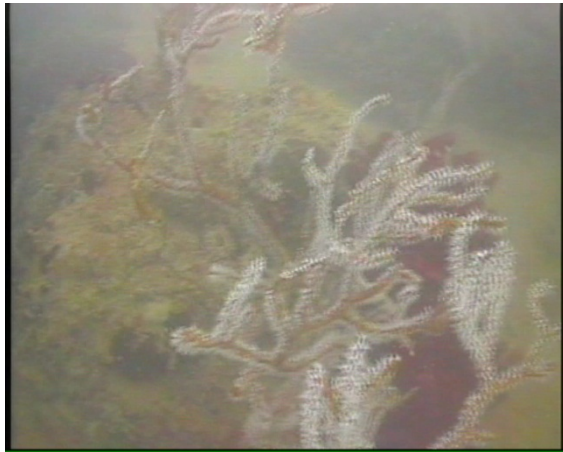
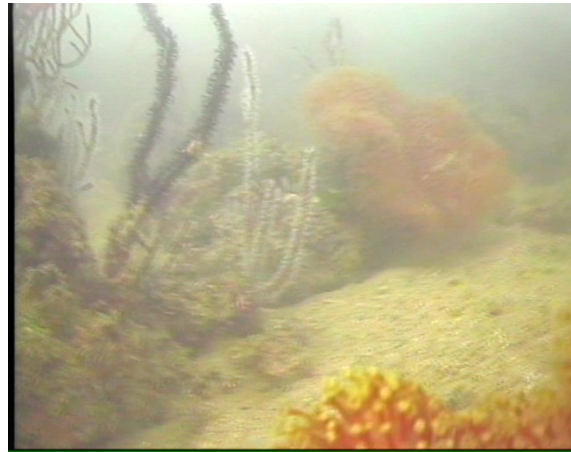
Plate A1 Images of Typical Benthic Assemblages

Pera Head – Turbinaria hard coral, seaweeds, rocks and entrusting algae

Pera Head – Turbinaria hard coral and soft coral

Pera Head – Branching soft corals, polyps out

Pera Head – Soft corals, rock and coarse sand substrate at base of reef slope

Drop camera surveys undertaken in 2012 confirmed there was no live coral or reef to support coral in the footprint of the proposed Temporary Barge Facility. However, near shore fringing reefal substrates occur at Pera Head (Plate A1), more than 200m to the south of the facility. These patchy reefs support hard corals and low profile reefs containing soft coral – sponge assemblages, with generally a low proportion of live cover. At Pera Head, 49 of the 269 locations recorded habitat suitable for live cover (i.e. rock) and 26 of the locations recorded live cover ranging from 5% to 100% cover at individual sampling locations. Figure A8 shows the locations where live cover and suitable habitat were recorded.
