# 1. About this Report

This Annual Environmental Report is provided to share yearly environmental performance with our stakeholders and meet the reporting requirements under the multi-media permit from the provincial government of British Columbia. It is submitted to the provincial government and made available to the public through the BC Works web site and at the Kitimat Public Advisory Committee (KPAC).

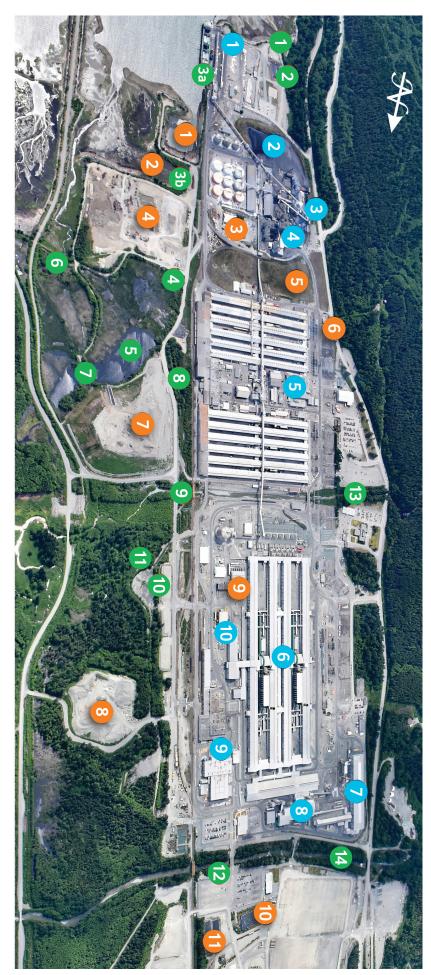
# **Figure 2.1** Kitimat Environmental operations.

In addition to the process related facilities, there are a number of environmental facilities for waste management, storm water management and managed sites. These environmental facilities are shown in Figure 2.1.

# **Effluent Collection and Treatment**

The spent potlining landfill is comprised of three separate subsections formerly used to dispose of spent potlining (SPL). The landfill is located south of Potroom 1A and north of the Anode Paste Plant (refer to Kitimat Operations map Figure 2.1).

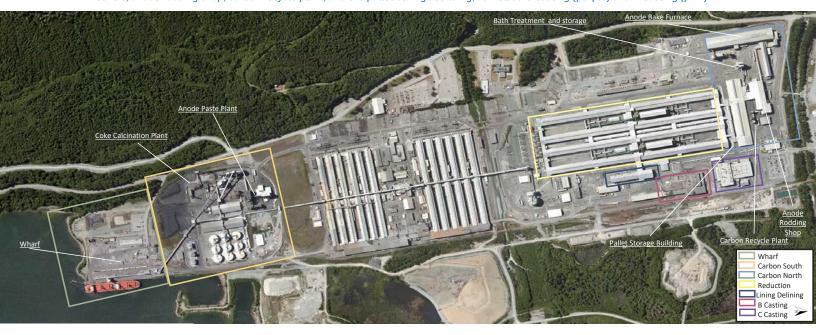
Figure 5.2 Operational Performance

There were 4 non-compliances (red) related to emissions monitoring in 2019, the remaining monitored discharge points were compliant (green).

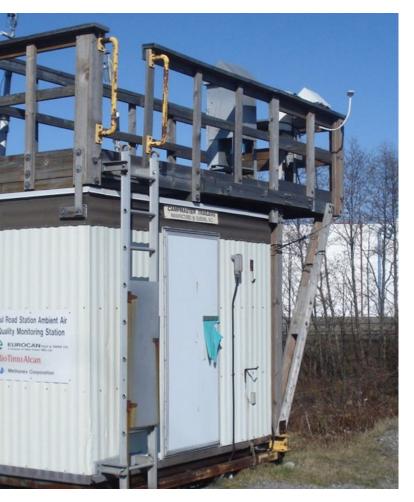
Figure 6.2 Hydrogen Fluoride Monthly Average Concentrations

HF monitoring is done with Picarro analyzers (cavity ring down spectroscopy) and are presented in both Table 6.2 and Figure 6.2. Since the smelter has been modernized, ambient HF concentrations are very low (less than 1 ppb).

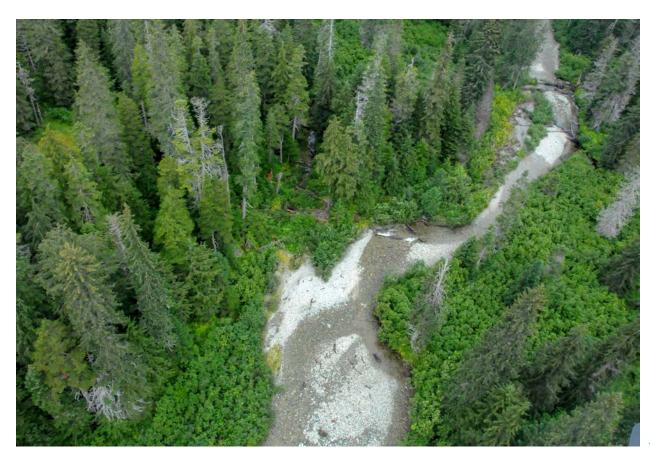
In 2019 changes were made to the vegetation monitoring and assessment program based on Dr. John Laurence's (plant pathologist consultant) recommendations. The recommendations were provided to the Ministry of Environment and Climate Change Strategy who also found that there were a number of redundant sites that could be removed. Therefore in the 2019 field-sampling season the number of sites were reduced from 40 to 27 (Figure 7.1).
