RTA Weipa Pty Ltd

# Amrun Project Marine Pest Monitoring Report

August 2019

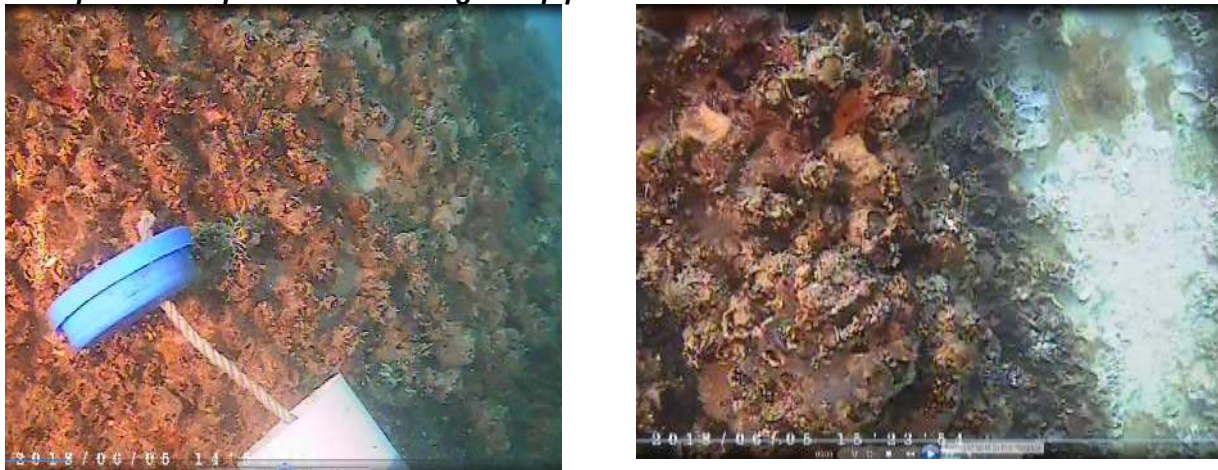
**Figure 5 Images collected from diver survey (continued)**

Pylon inspections occurred 29 May to 06 June 2018. No AGM were sighted or recorded during diver or video analysis. Images from the surveys are provided in **Figure 4** and **Figure 5**.

Analysis of videos noted growth at all locations was similar and included:

- Tertiary biofouling was observed on all vertical pylons with coverage at approximately 90% consistent on 10% soft biofouling and 90% hard. Hard cover predominately consisted of barnacles with a few oysters (fake pearl and winged), oysters were mainly sighted in the top 5 metres. Soft cover consisted of ascidians, sponges and algae which often cover the hard cover.
- Horizontal frames generally had lower levels of biofouling (secondary) at approximately 40% mainly consisting of barnacles with a thin sediment layer on top.
- A clear intertidal zone was identified at the top of the pylon, this was restricted to hard cover predominately consisting of barnacles and oysters.
- No areas of dense bivalve assemblages were recorded.
